NHTSA Technical Report

DOT HS-803 705

SCHOOL BUS CARBON MONOXIDE INTRUSION

September 1978

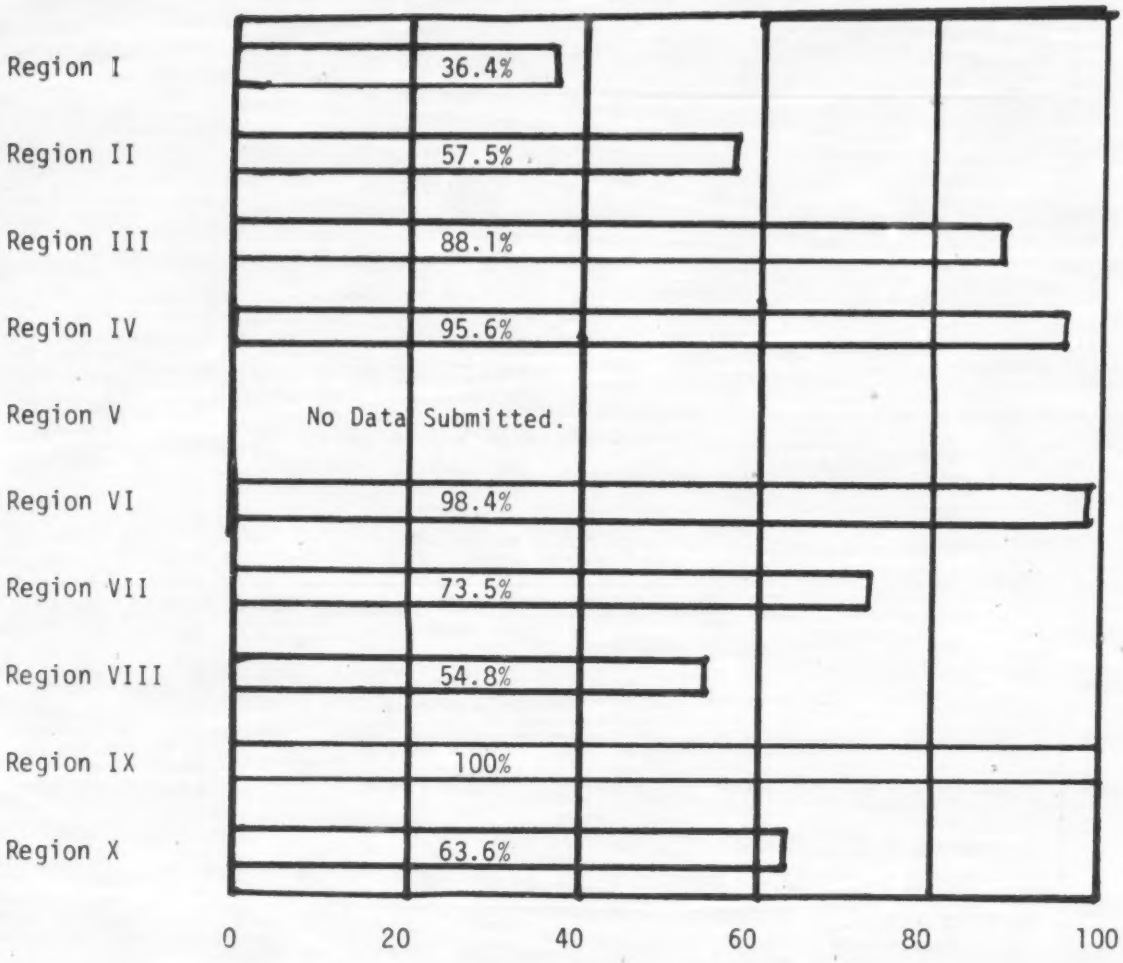
Figure 11. Average PPM CO Summary
Bar Chart

A summary of data received is presented in Figure 9 "Carbon Monoxide Average Reading Test Summary" and Figure 10 "Carbon Monoxide Maximum Reading Test Summary." These charts categorize data into values above and below 20 PPM for each NHTSA Region. A total of 7.2% of the school buses tested had average carbon monoxide readings above 20 PPM, and a total of 20% had maximum readings above 20 PPM. Data is presented in bar chart format in Figures 11 and 12.

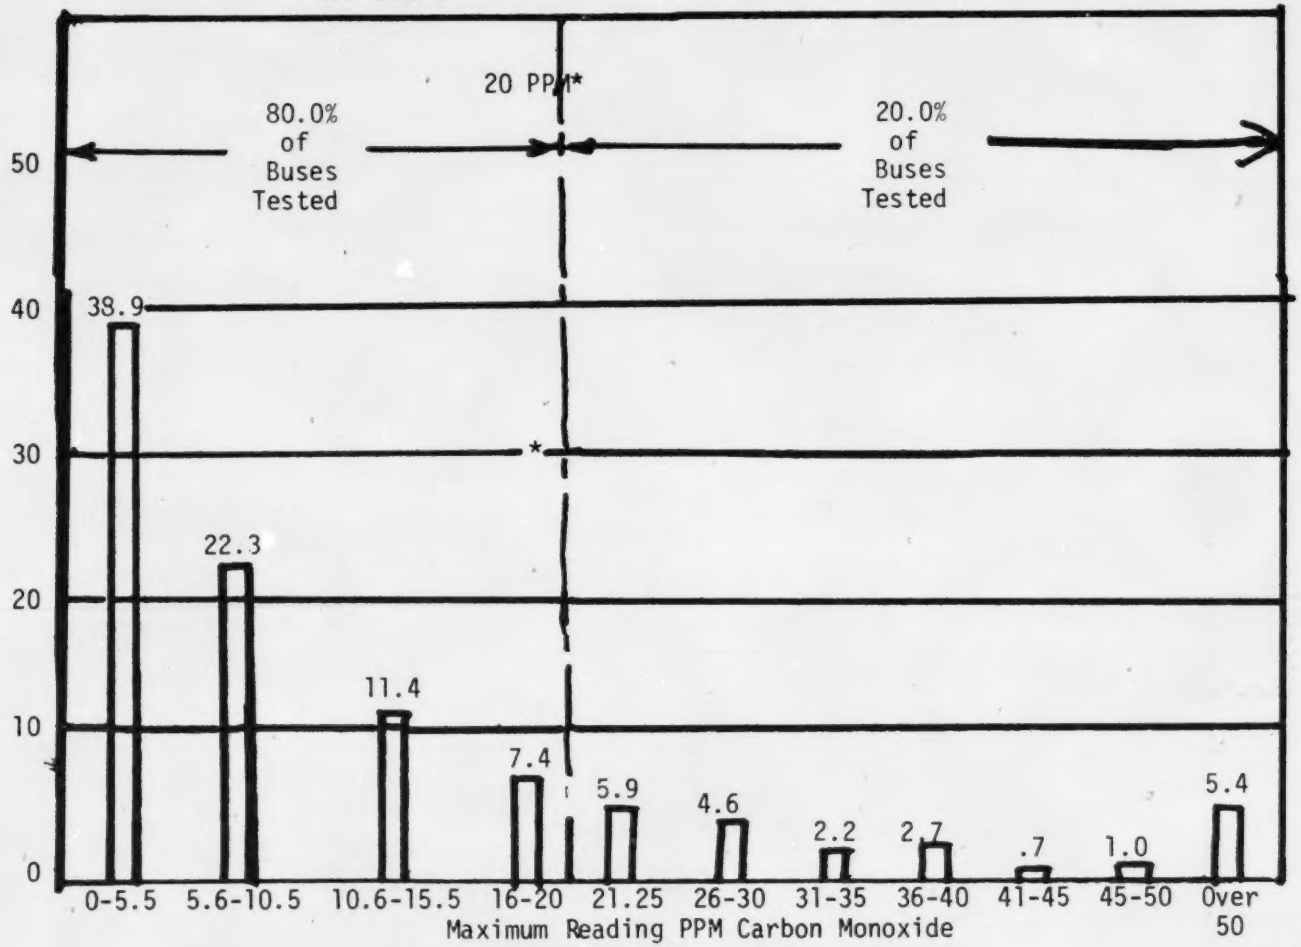
Figure 15. Maximum Parts Per Million Carbon Monoxide Readings by NHTSA Region Bar Chart

3. The interior CO "maximum" PPM readings on all buses tested showed that 5.4% of all buses tested exceeded 50 PPM at some time during a run (Figure 15).

Figure 13 shows a summary of maximum readings in 5 PPM increments for each test site and NHTSA Regions (Figure 14). Figure 15 is a bar chart display of these maximum readings versus the percentage of school buses tested out of 591 total. 80.0% of all school buses tested had readings below 20 PPM and 20.0% had readings above. Of special significance in this chart is the 5.4% of the school buses tested that had maximum readings above 50 PPM of carbon monoxide which exceeds the allowable levels of the EPA, OSHA, NIOSH, and Colorado standards.

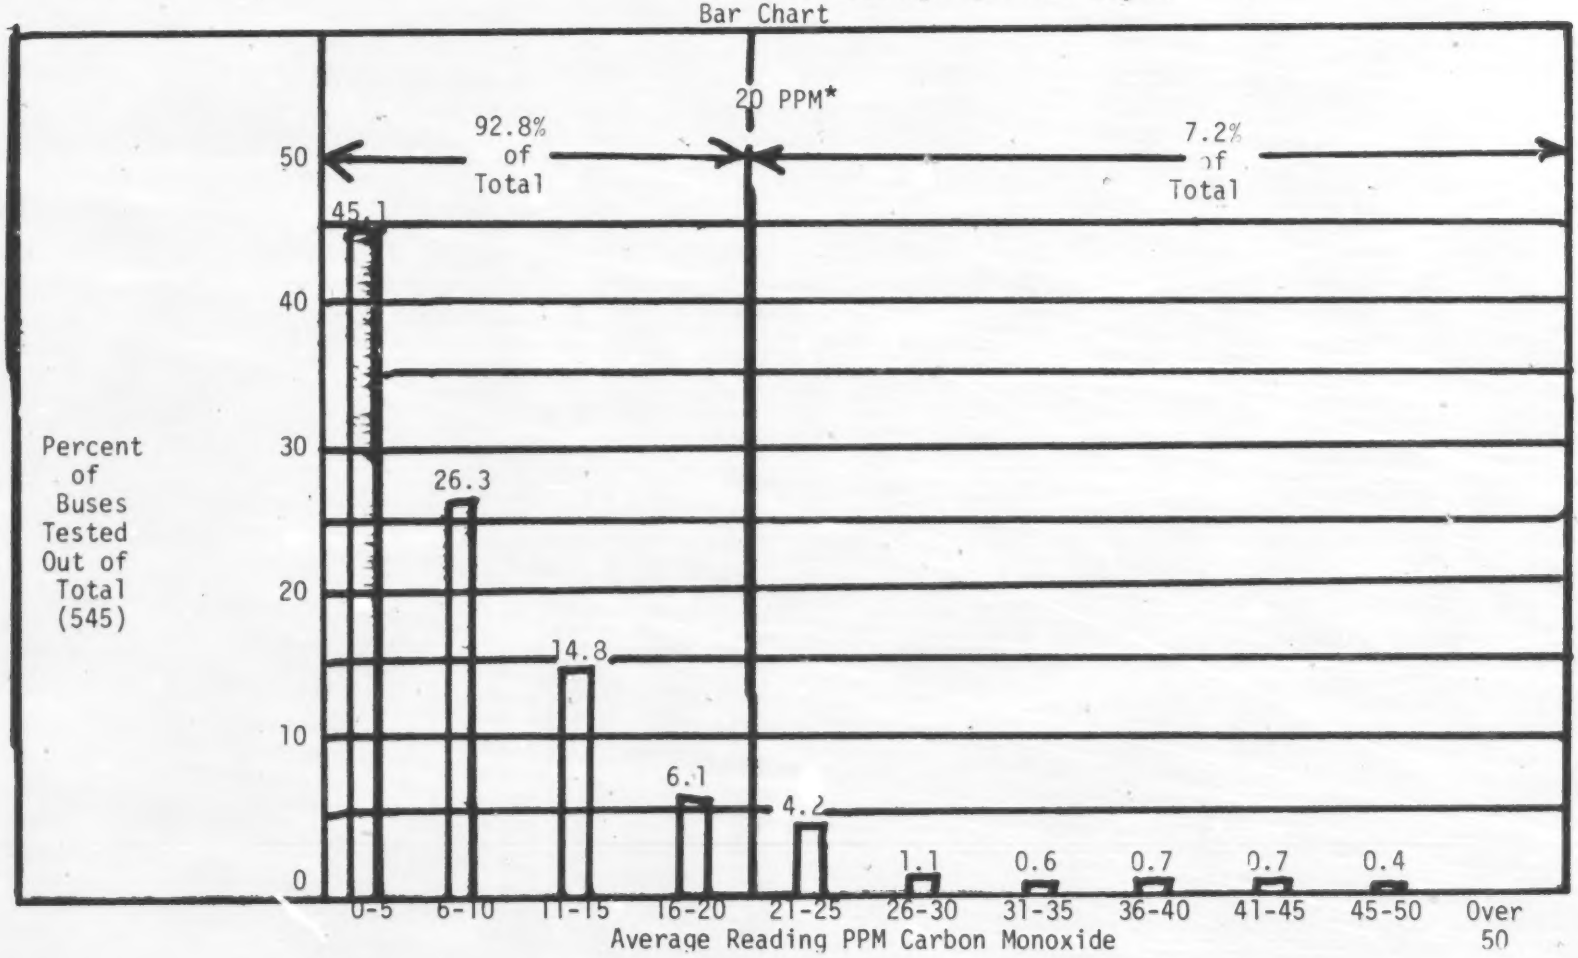
Figure 17. Average Parts Per Million Carbon Monoxide Readings by NHTSA Region Bar Chart

Figure 16 shows a summary of average readings in PPM increments for each test site and NHTSA Regions. Figure 17 is a bar chart display of the average PPM readings versus the percent of school buses tested out of a total of 566. 92.8% of the school buses tested had readings above 20 PPM and 7.2% had readings above 20 PPM. 1.8% of the school buses had average readings in excess of 35 PPM which exceeded EPA, OSHA, NIOSH, and Colorado standards.

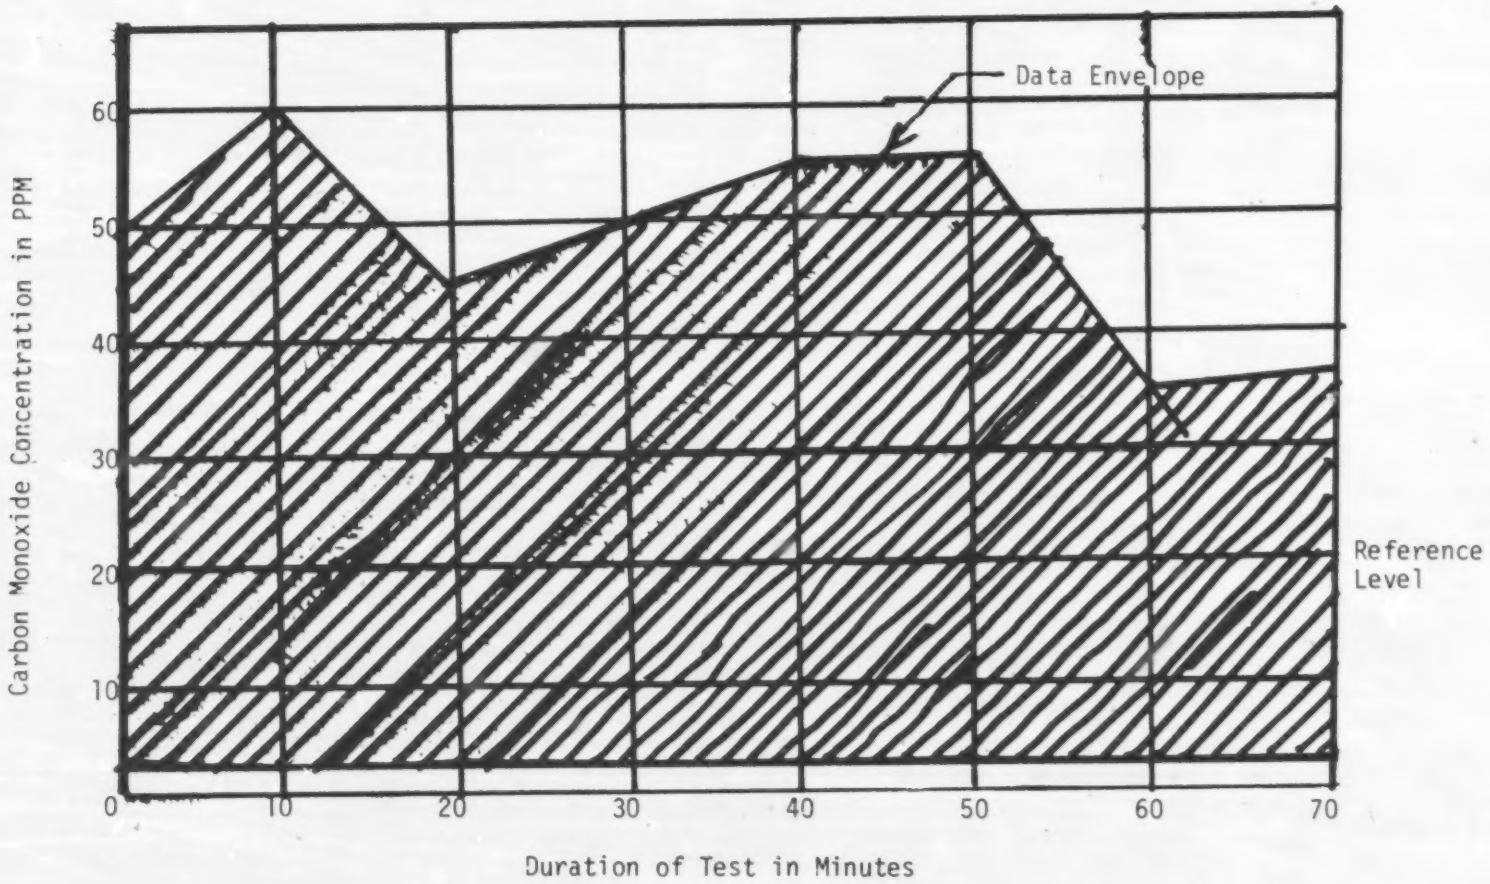
Figure 18. Washington State
February-March 1977
18 School Buses

Shaded area represents the data envelope within which all data points fall.

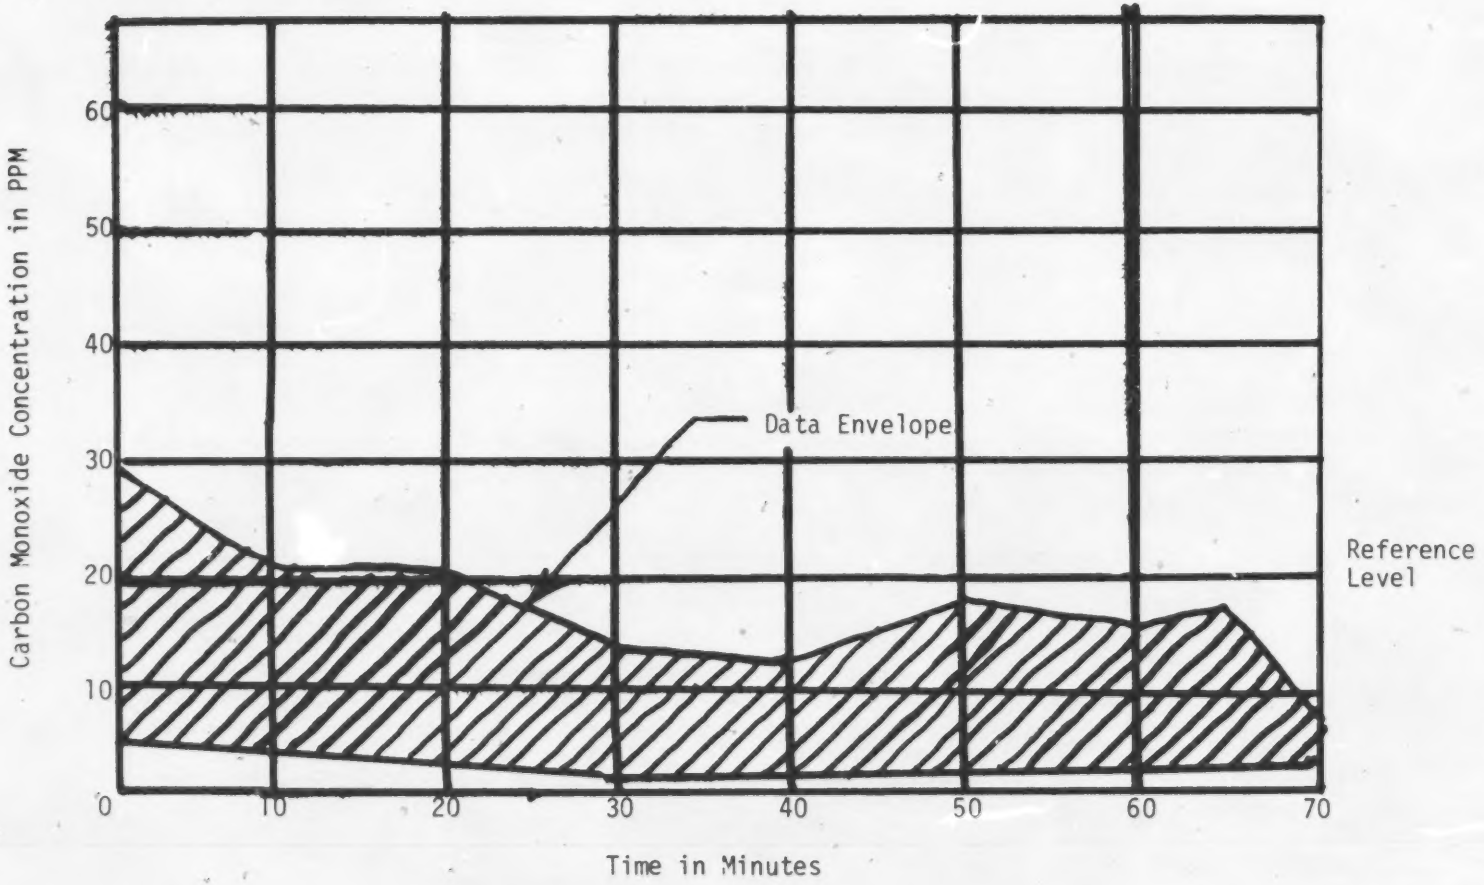
Figure 19. Greeley, Colorado
March 1977
20 School Buses

Shaded area represents the data envelope within which all data points fall.

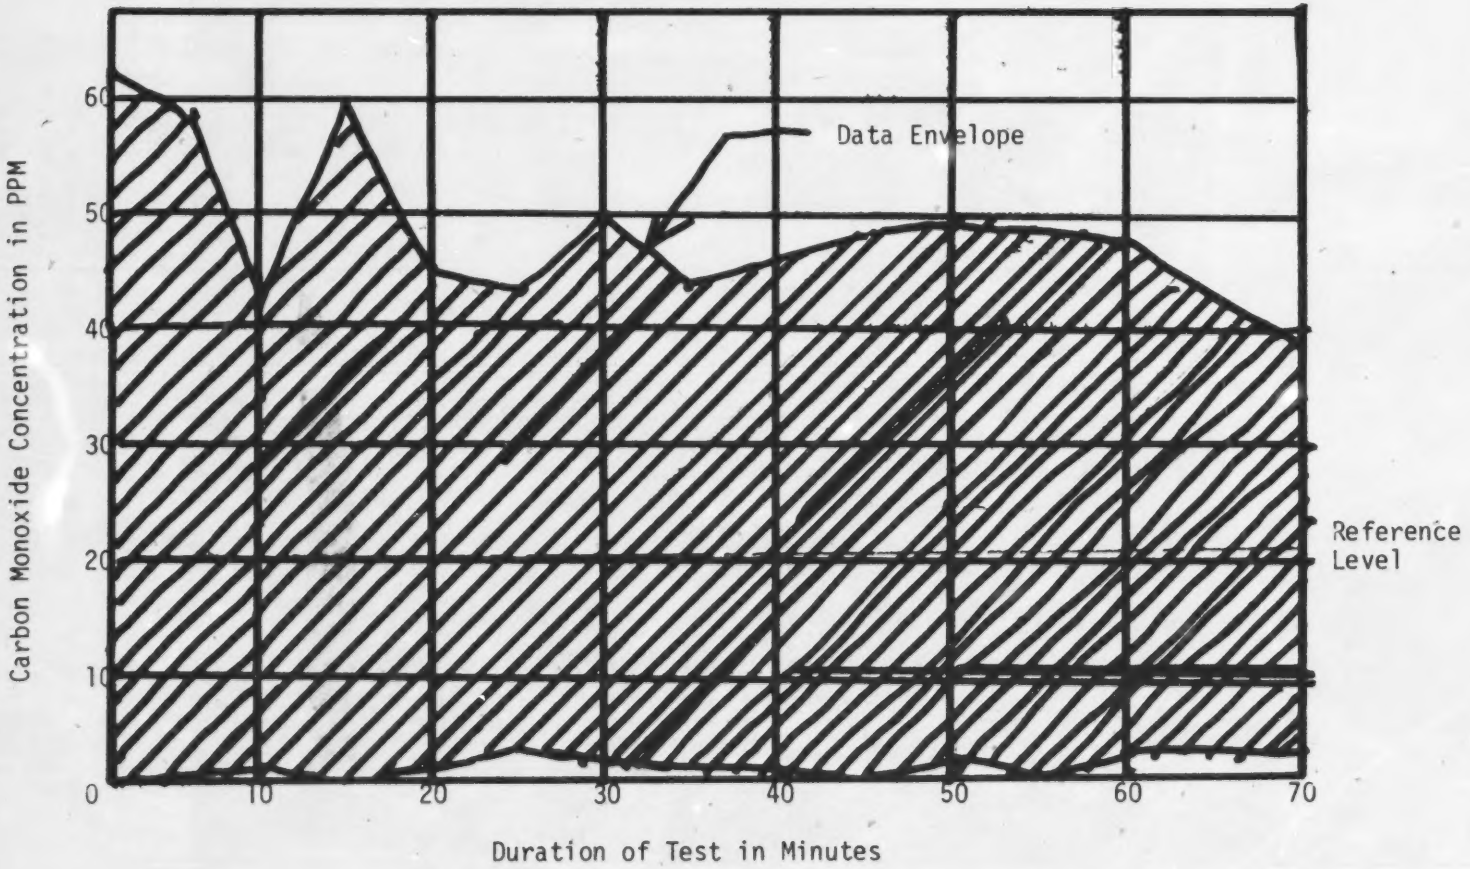
Figure 21. Connecticut-Rhode Island
December 1976
33 School Buses

Shaded area represents the data envelope within which all data points fall.
